JAPANESE GULCH FISH PASSAGE DESIGN AND HABITAT RESTORATION

Project Location
Mukilteo, Washington

Client
City of Mukilteo

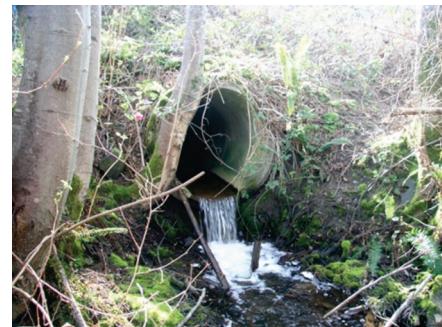
Before: Raised culvert under railroad grade poses fish passage challenge.

Working closely with our team members and the City of Mukilteo staff, CEC developed a plan to address the passage barrier in the junction box for a fraction of the initial cost projected by the City Engineer. This freed up project budget to address another upstream passage barrier in the form of a perched culvert. The team developed a cost effective solution to this barrier as well. In addition, the stream assessment identified a historical channel that CEC believes was abandoned 40 to 60 years ago. The team developed a conceptual design to move the stream from its existing heavily engineered channel (three concrete weirs and a concrete flume) back to its historical channel thereby bypassing three additional passage barriers and opening up more than twice the length of channel and habitat for future fish use.

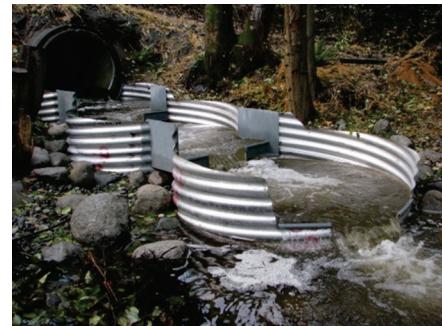
After: Engineered fish ladder provides adequate fish passage for coho salmon.
